100 AREA WASTE SITE RECLASSIFICATION PACKAGES (ATTACHMENT 1)

26 Waste Site Reclassification Packages

100-B Area Technical Baseline Report

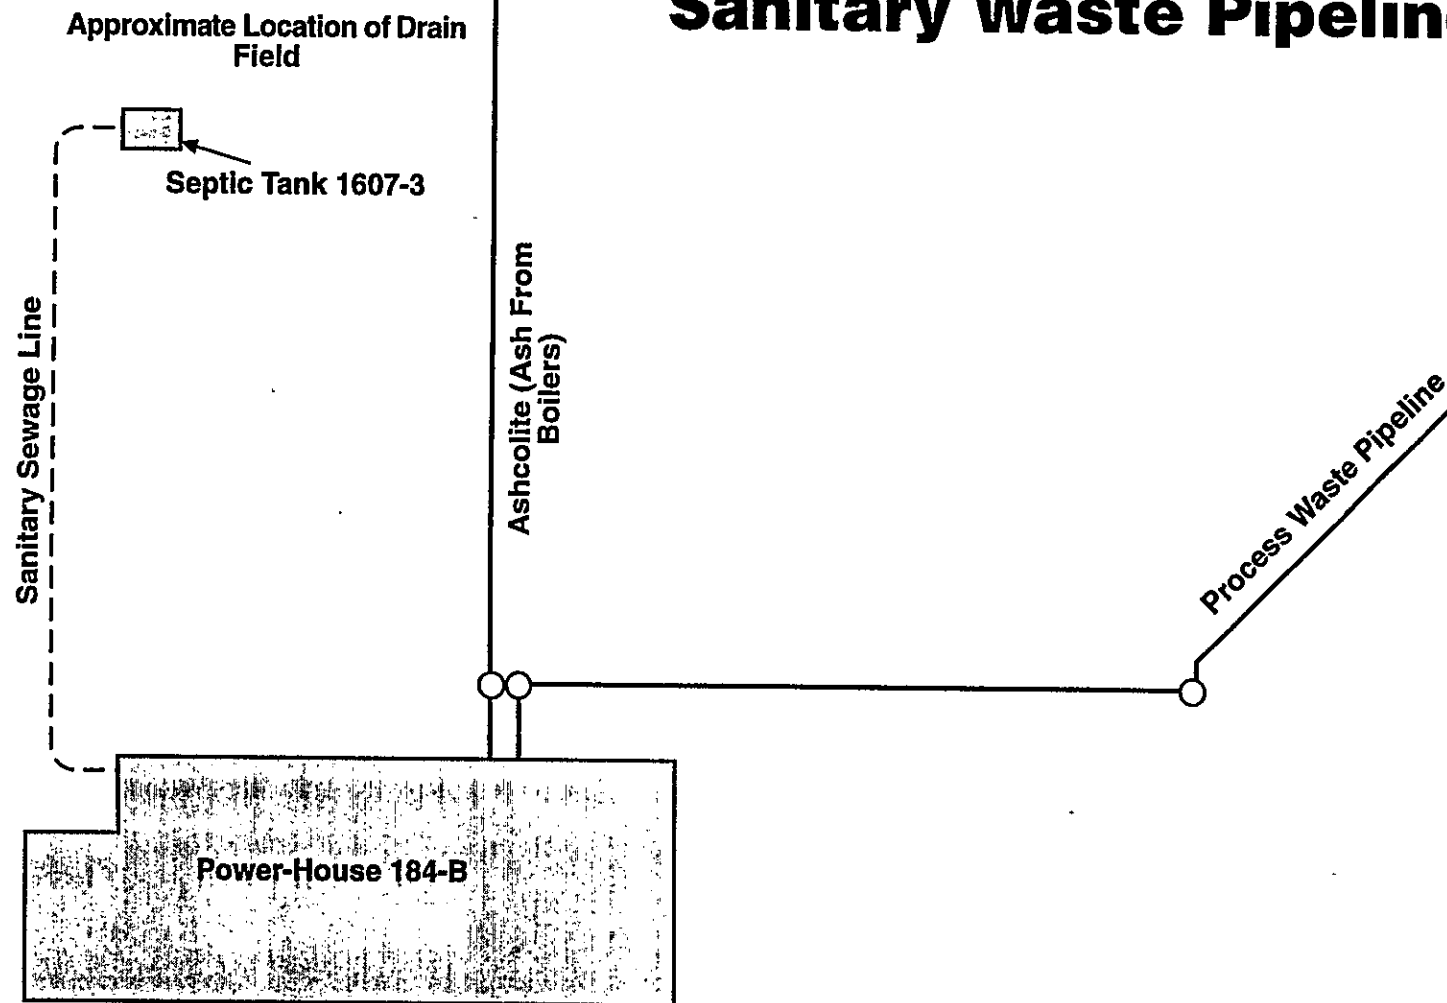
184-B Power House Showing Separate Sanitary Waste Pipeline

Computer Enhanced Clarification
of applicable portion of
Hanford Site Drawing M-1904-B, Sheet 5

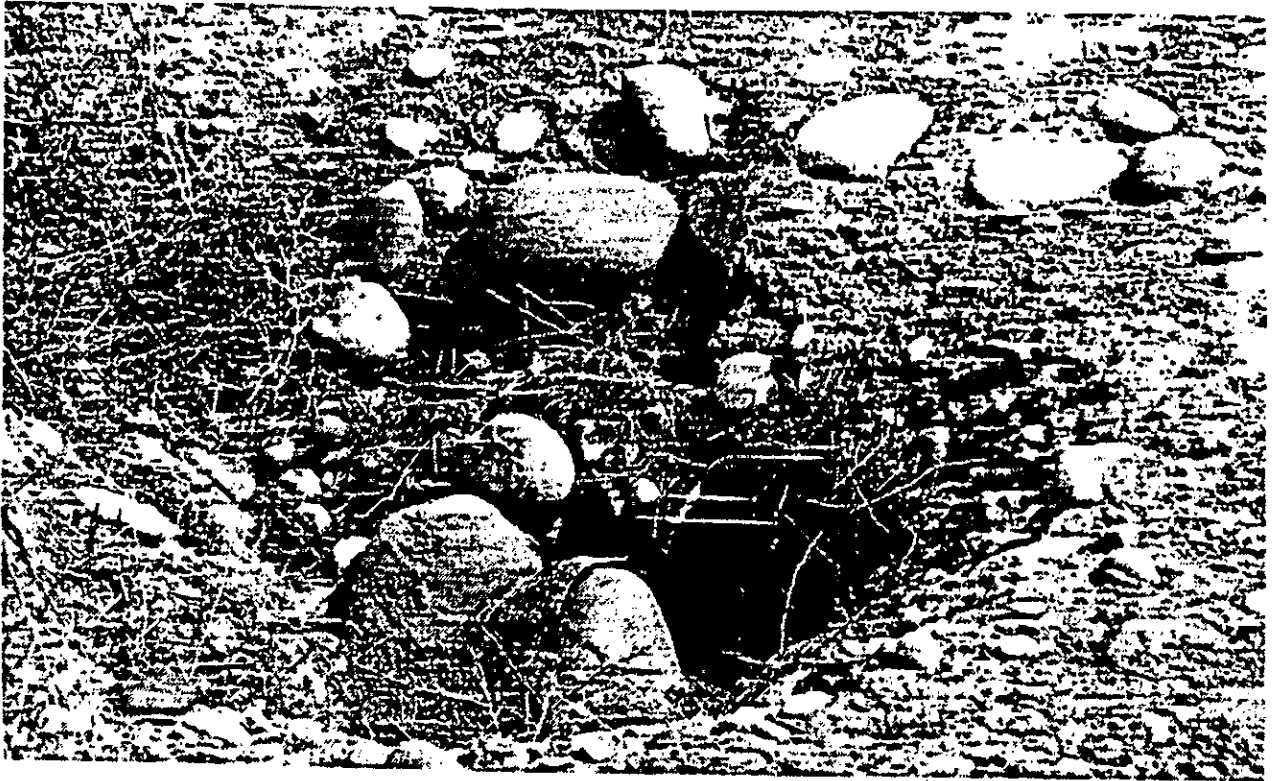
Figure 4-32. Subsidence Near Salt and Brine Pit.

Site Comment: The site was demolished in situ March 1988. Both pits were sampled for radiation and EP toxic metals. Samples showed the NaCl concentrations were greater than 10% (hazardous material limit). No significant radioactive materials were found. Northwest Environmental Services, Inc. removed all hazardous waste and salt cake from the pits and certified them clean before in situ demolition and final grading. The pits were partially backfilled with rubble and leveled to grade with clean fill. Recently, a soil subsidence has appeared at the site that contains steel grating and concrete debris.

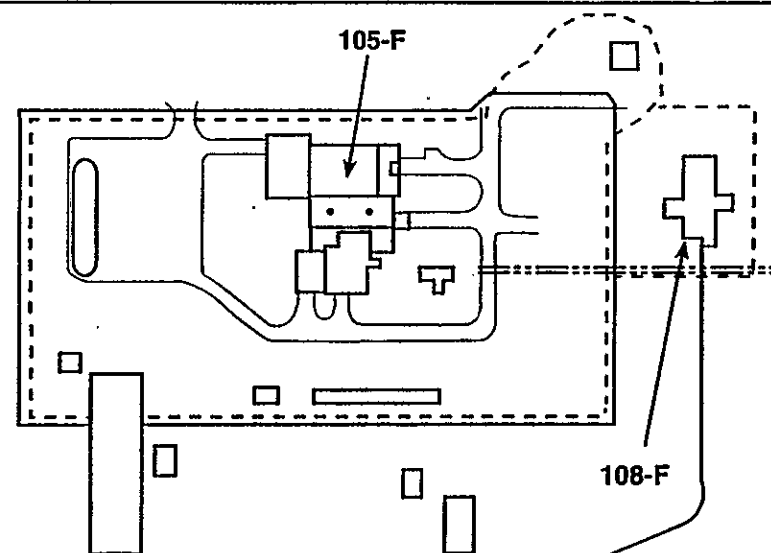
100-F-1 Depression Site Showing Approximate Location of Suspected Buried High Purity Water Pipelines

High Purity Water Pipeline

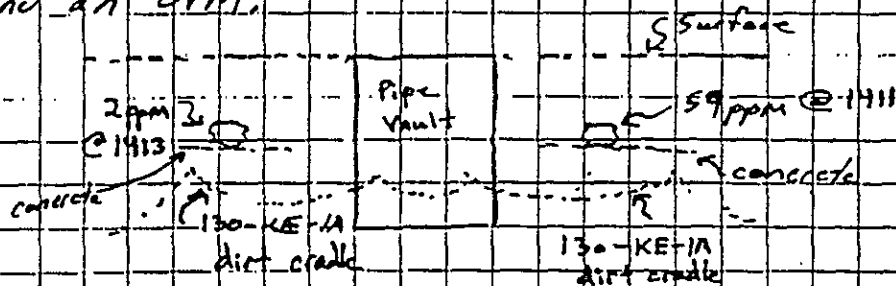
were used to hold
diesel fuel1230 - Arrived at UST storage tanks site. Assessed project site
and photos of tanks 130-KE-1A & 1B were taken.1330 - Diesel UST 130-KE-1A was lifted from excavated pit
and photos of ~~sub~~¹⁰⁻⁶⁻⁹² tank ~~was~~¹⁰⁻⁶⁻⁹² were taken as outside of
tank was inspected for leaks. Tank looked in good condition.
Tank was placed on flatbed truck for removal.1348 - UST 130-KE-1B was lifted from excavated pit. Tank
was inspected for leaks and photos were taken. Tank looked
in good condition. Tank was placed on flatbed truck for
removal.1405 HRS - Tank excavation was surveyed by HPT. Less than
background.1411(1413) - Two discolored soil spots were analyzed using a plastic bag
and an OVM.

Drawing not to scale - looking SSW toward 105-KE building.
